**ELECTRONIC CALCULATOR 130**

**SERVICE LETTER**

SUBJECT: Plug-in Circuit Card Jacks

SUBJECT: Plug-in Circuit Card Jacks (Friden No. 803206)

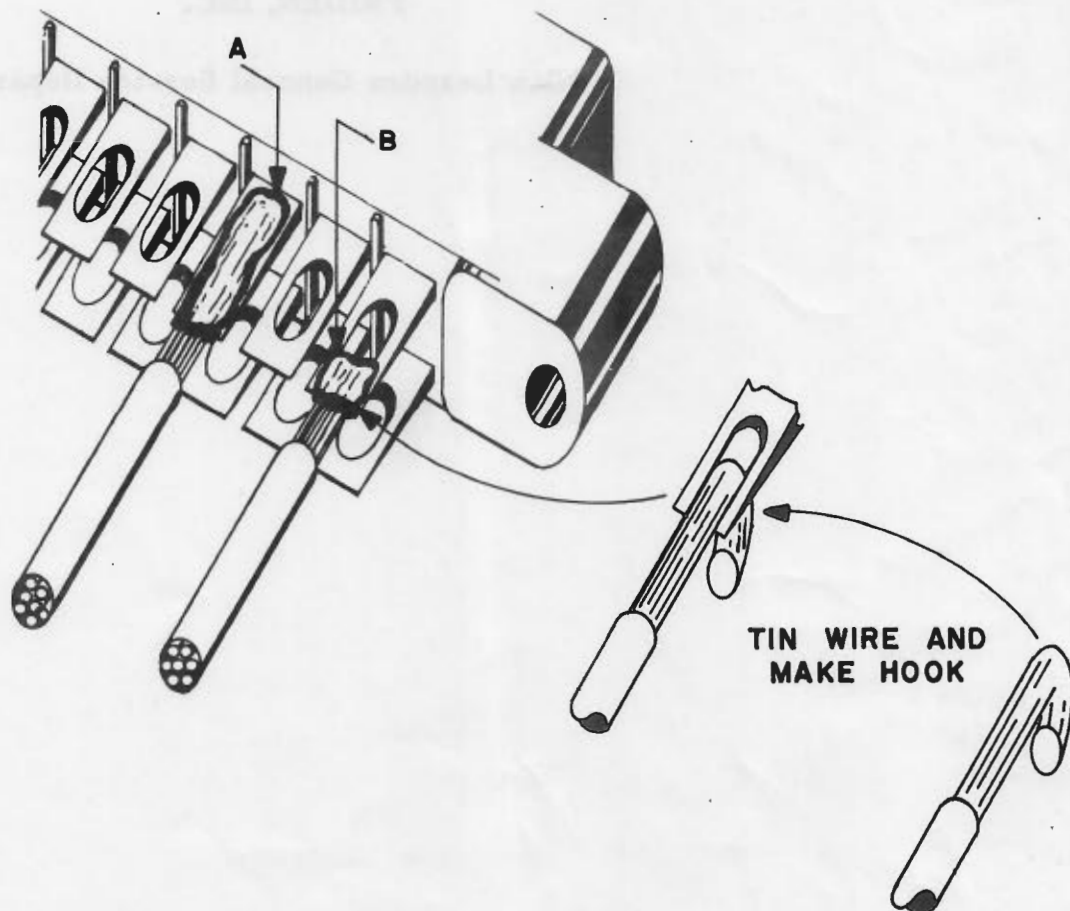
REASON: Intermittent troubles have been traced to bad plug-in card jacks on some machines in the group serialized 1040-1090 (approximately).

Point A illustrates soldering technique that is causing trouble. Point B illustrates method to be used when replacing a plug-in card jack.

INSTRUCTIONS: Replace jacks if intermittent operation results when pressing on a plug-in card or if servicing indicates trouble in jacks.

When replacing a jack, the new jack should be placed alongside bad jack and leads transferred one by one to corresponding terminals. Otherwise, each lead will have to be tagged since these wires have no number coding.

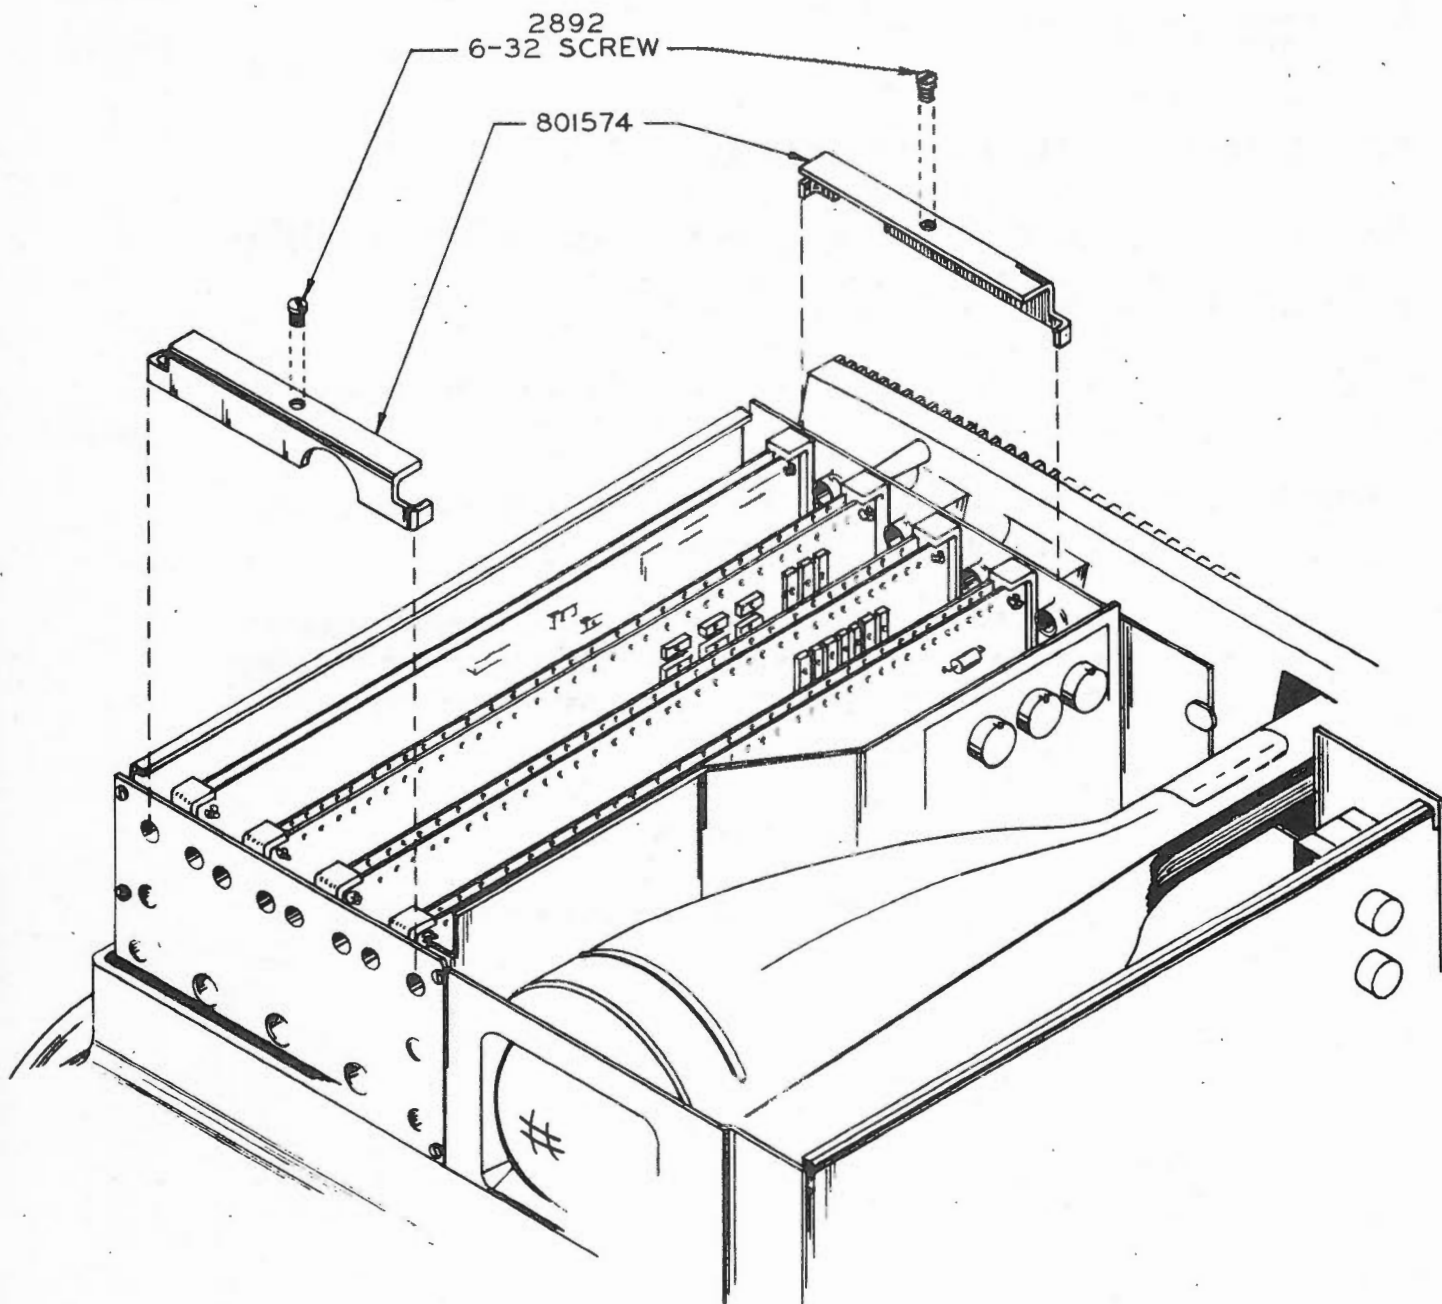
REASON: Present installation of only one card retaining plate is unsatisfactory.

INSTRUCTIONS: Remove present retaining plate and replace with double retaining plates as per sketch.

NOTE: In cases of extreme difference in card heights, it may be necessary to cut a slit(s) in the lip of the plate and form the lip up or down for a particular card, or cards.

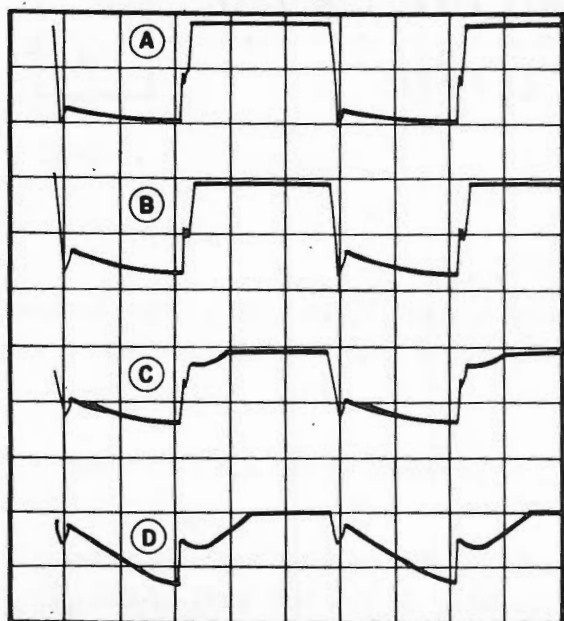
A "dim display" complaint should be first checked by reducing the intensity until the display is barely visible. If the left half of the display is dimmer than the right, the DC restore diode is probably leaky. If the beginning of each segment is brighter than the last half or if there is a dot at the beginning of each segment with the last half of the segment dimmer, then the DC restore diode is open. In either case, replace the DC restore diode regardless of any resistance measurement you may make across the diode.

Another frequent reason for insufficient brightness is insufficient high voltage. This may be checked by measuring the DC voltage at point A of the attached schematic. A reading of -510V should be secured providing resistors are at or close to zero (0) percent tolerance. If this voltage is low, check the output of the a-stable. The A stable waveform should be a 2KC (500us) symmetrical waveform of about 10 volts amplitude. A defective a-stable output, not oscillating or unsymmetrical oscillation, is one of the most common reasons for overheating of the 10 ohm 2W resistor.

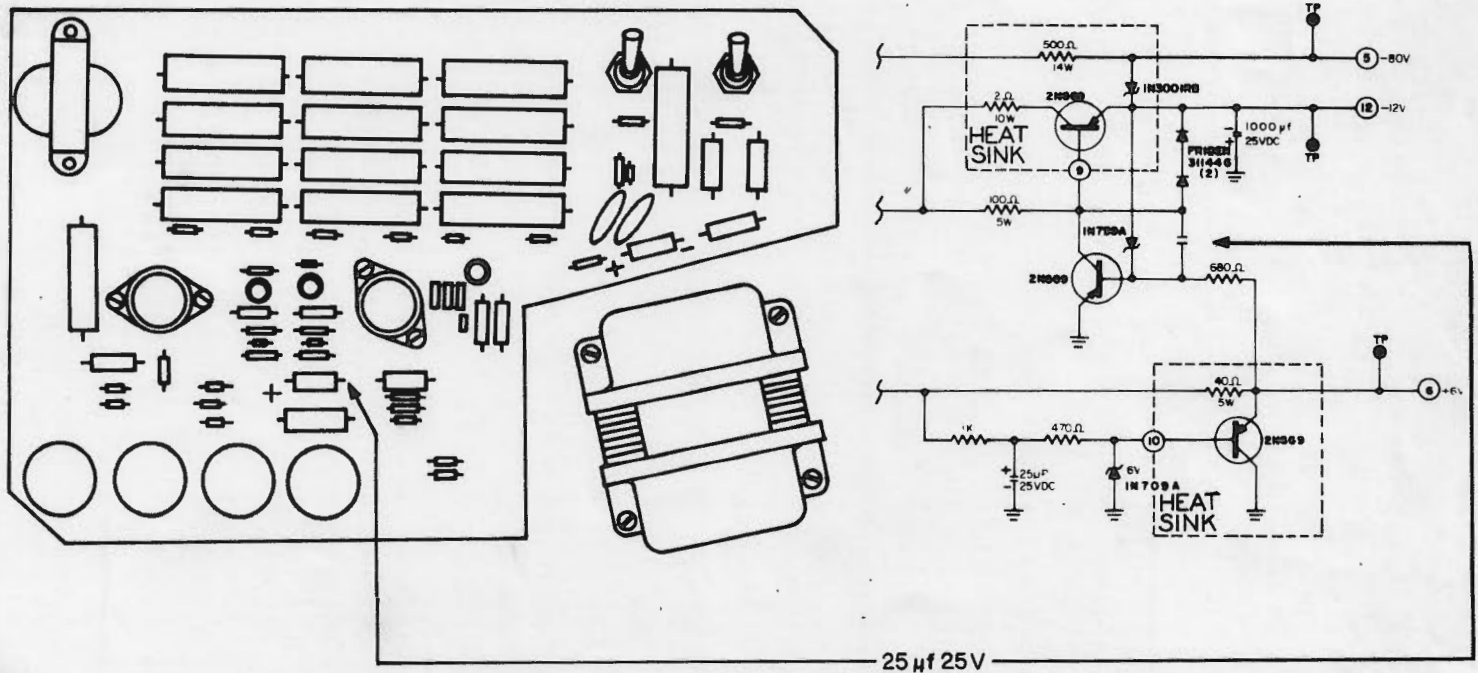
FIGURE 1

Remove the diode indicated in Figure 1. This is referenced in the EC-130 construction file under 1580.020.0 and in the EC-132 construction file under 1600.021.0. Removal of this diode will eliminate one writing pass of R1 so that R1 will be of the same intensity as R2, R3, and R4. Readjustment of the intensity control may be required. If "wavering" still persists, replace old style power transformer with new style transformer. The old style transformer has the part number (804002) stamped into the side, while the new transformer has the number on the top. The new transformer must be installed in the same position as the present one with the laminations approximately parallel to the side frame, or additional "waving" may be created.

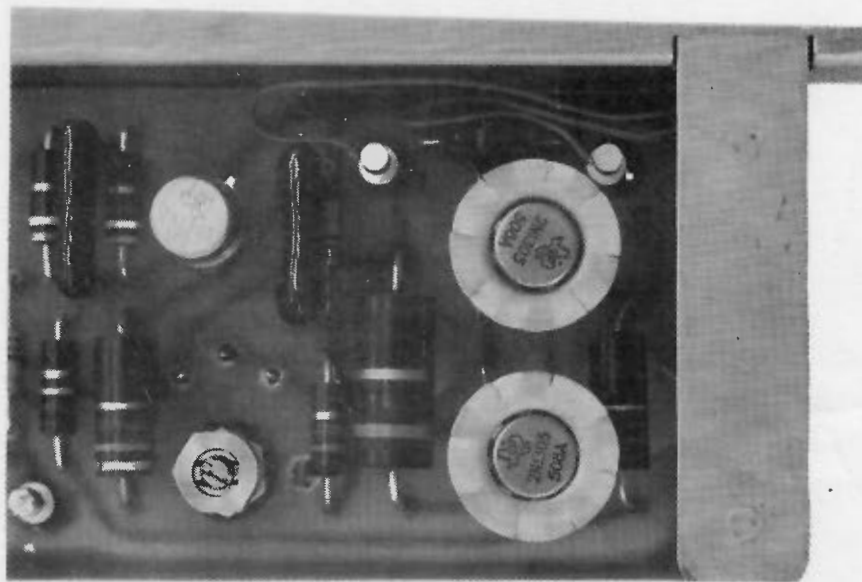
REASON: Field reports indicate a rise in open write coil problems. This is frequently caused by the transistor heat-sinks touching each other, or the write coil terminals.

INSTRUCTIONS: Make sure that the transistor heat-sinks do not come in contact with each other, or adjacent terminals. Care should be taken when replacing transistors so that they will not touch the bottom cover.

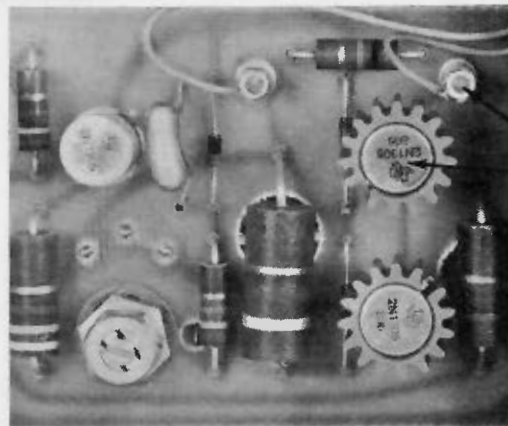
PROBLEM AREA

Special care must be exercised when troubleshooting the write-amplifier circuitry to prevent shorting the coil terminal to the nearby transistor as illustrated! Even a momentary short will open the launch coil.
