# The TELEFUNKEN RA 741 Analog Computer

The RA 741

The RA741 is the direct predecessor of the TELEFUNKEN RA742 analog computer and the successor of the RA700 analog computer.

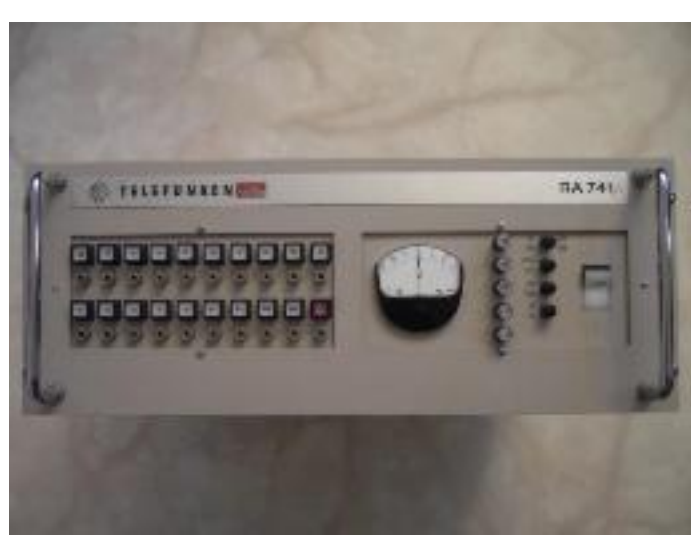
Whenever I attempt to restore an old computer I will never just switch it on - it is way too dangerous since failures and errors might destroy other circuits leading to sheer never ending trouble. So the first thing I always have a look on is the power supply which is located in the right half of the upper drawer shown in the picture on the left.

The left half of this drawer contains fifteen of the operational amplifiers of this computer.

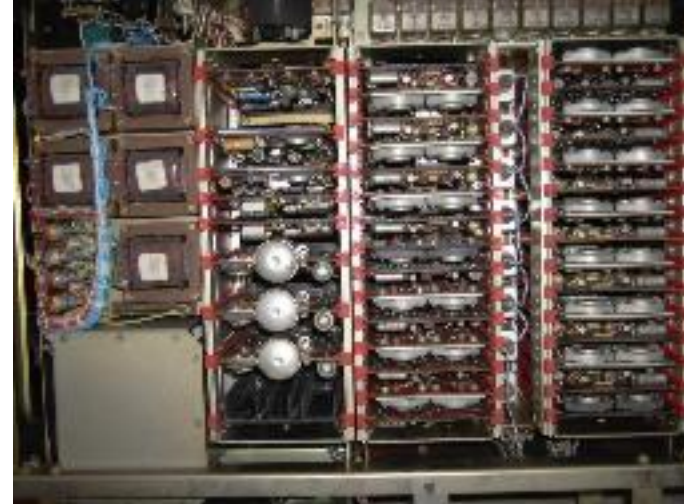
The picture on the right shows the innards of the upper drawer (the front panel is on top of the picture). On the left hand side are the large filter inductors and the silicon rectifier diodes. Next to this is a card cage holding the regulator cards and some additional circuitry for the power supply.

The two card cages on the right hand side of the picture hold the 30 cards representing the 15 operational amplifiers. Each amplifier consists of a main amplifier and an auto-zero (support) amplifier as well as one half of a chopper relays (these special purpose relays can be seen between the two operational amplifier card cages).

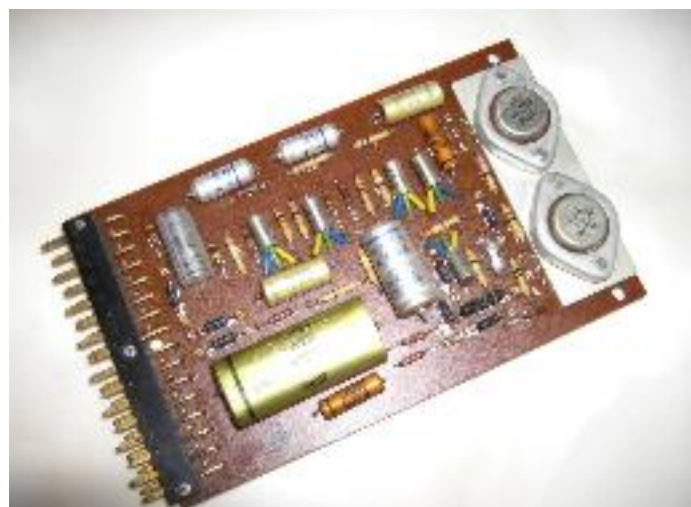
The picture below left shows the main amplifier part of an operational amplifier of the TELEFUNKEN RA741. On top of the card are two high power Germanium transistors which form the output stage of the amplifier. This card alone could act as an operational amplifier (with quite impressive technical data even for today's standards). But this amplifier would suffer from drift as every simple operational amplifier does. Drift is a real problem in analog computation since errors caused by (temperature) drift effects will accumulate in the integrators and render calculations useless. In normal consumer applications this drift poses no problems since all amplifiers in these application areas are capacitively coupled to their surrounding circuitry so DC drift is no problem at all.

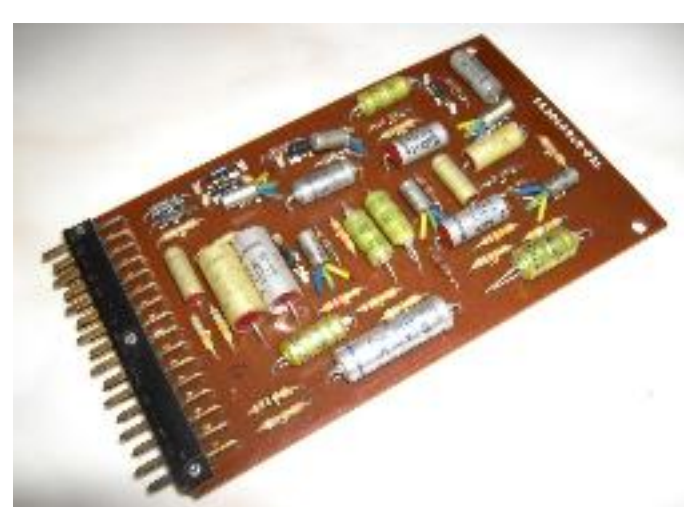
The picture on the right shows the support amplifier which is used to amplify the drift signal present on the summing junction of the main amplifier shown above. The input signal to this support amplifier has already been chopped by the electromechanical chopper relays so this amplifier can be connected as an AC coupled (and thus drift free) amplifier. The output signal is then rectified (note the two black Germanium diodes on the left hand side of the printed circuit board) and fed back to the main amplifier.

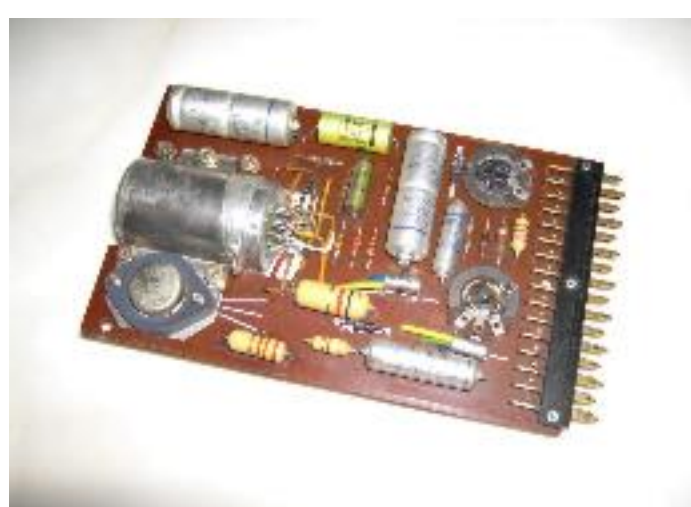
- Unregulated voltages for powering relays and lamps.
- Normal regulated voltages for powering the operational amplifiers, etc. (The picture on the left shows one of those voltage regulators. The big relays on top of the card is a special bistable relays which will trip on overvoltage as well as on overcurrent to protect the regulator and the analog computer.)
- Two highly stabilized voltages of +10 V and -10 V respectively. These voltages represent one positive and one negative machine unit and are the basis of all calculations. The regulators for these voltages make use of drift corrected operational amplifiers!

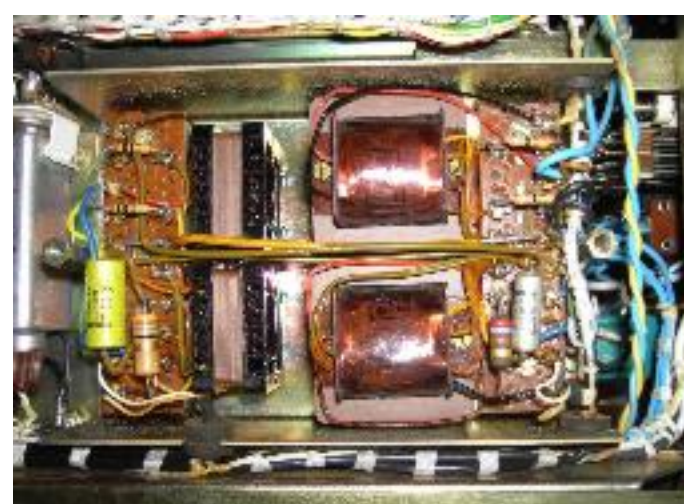
But nevertheless, the problem remained - the rectifier control voltage looked awful and not a bit like a square wave as it should. It turned out that the 400 Hz voltage amplifier shown in the picture on the right was defective, too. This amplifier is an interesting device (apart from the fact that it is shown only as a white rectangle on the drawings). It is a push pull amplifier with transformers for decoupling and it quite closely resembles an audio amplifier of the 1960ies. It turned out that one of the power transistors driving the pull side of the circuit was defective. (In the picture four transformers can be seen - the two small transformers on the left side are part of the rectifier control voltage amplifier while the two transformer on the right hand side are part of the higher power chopper voltage amplifier.)

Fortunately the first thing I did was to have a look at the two 400 Hz voltages for the choppers and the synchronous rectifiers. The chopper voltage was there and looked quite good. The rectifier control voltage looked horrible and was only 200 Hz which was interesting since both voltages are derived from a single signal source. :-)) It took me about two hours to understand the 400 Hz generator circuit - just to realize that it should work but it did not work. Half an hour later I found out - by mere accident - that one of four potentiometers needed to set frequency and phasing had deteriorated during the last 40 years (that is not what I would call quality :-)). Cleaning the slider and the sliding surface cured that and both voltages had the correct waveform at the outputs of the 400 Hz generator card.

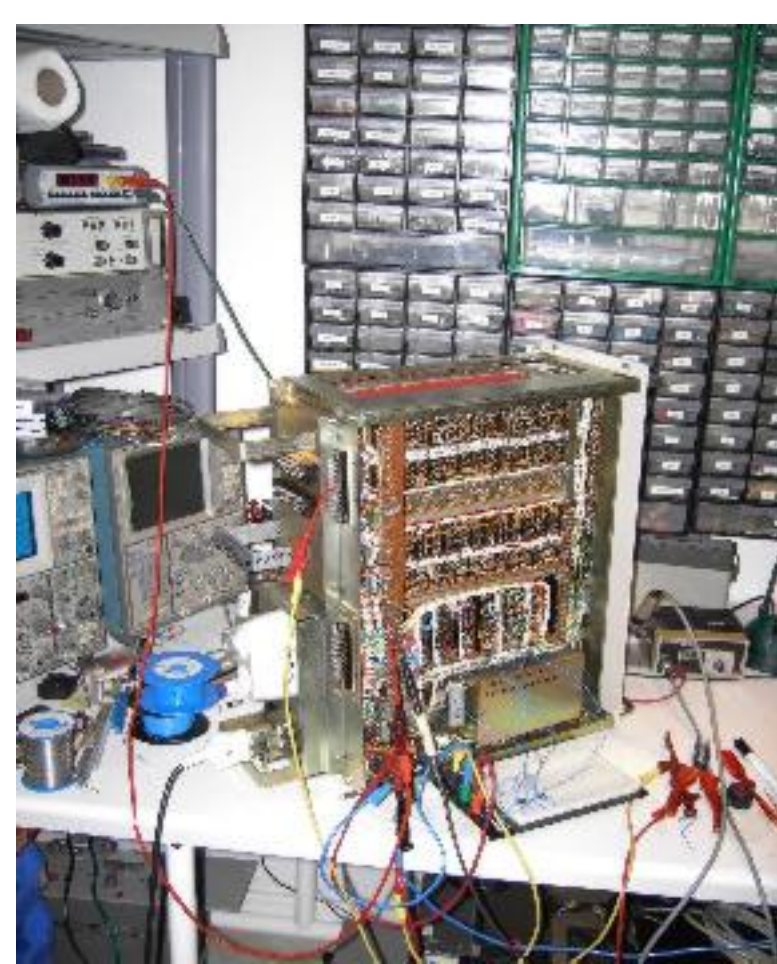
Alas - the +/- 10 V power supplies still did not deliver +/- 10 V. So I turned my attention to the two operational amplifiers (again) - this attempt can be seen in the picture on the left (please note the yellow cable leading to the upper plug on the back of the drawer - whenever you want to run the upper drawer removed from its rack, be sure to ground pin A4 of this jack to energize relays 2 which will cause the internal voltage reference to be used - otherwise the +/- 10 V levels will be undefined - this feature is used to connect several RA741 in parallel with one computer being master and defining the signal levels).

After some experimentation it turned out that both operational amplifiers were defective (by the way - here only the support amplifier part of a complete operational amplifier is being used - the voltage regulator acts as the main amplifier).

After looking at the two circuit boards and realizing that I am really short of proper Germanium replacement transistors I decided to make an accommodation - I would try to use two modern, of the shelf operational amplifiers instead of the two printed circuit boards full of Germanium transistors and diodes (it was about 2 AM when I decided to do this :-)). By the way - should you happen to have some spare Germanium transistors left (AC12x, AC17x, etc.), please do not throw them away - I would be glad to give them a new home if you want to get rid of them. :-))

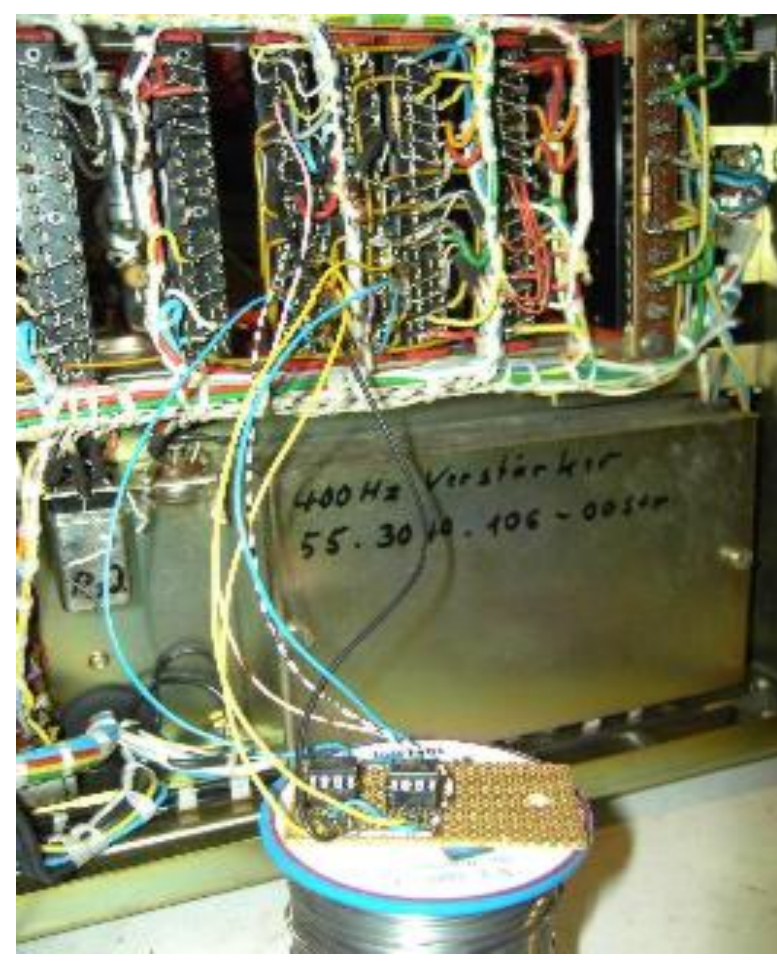
The two pictures below show my solution. In the picture on the left two OPA27 integrated circuits mounted on a small piece of perfboard can be seen. It turned out that these two amplifiers worked perfectly in this circuit so I decided to quit thinking about debugging the two original operational amplifiers and use this solution instead.

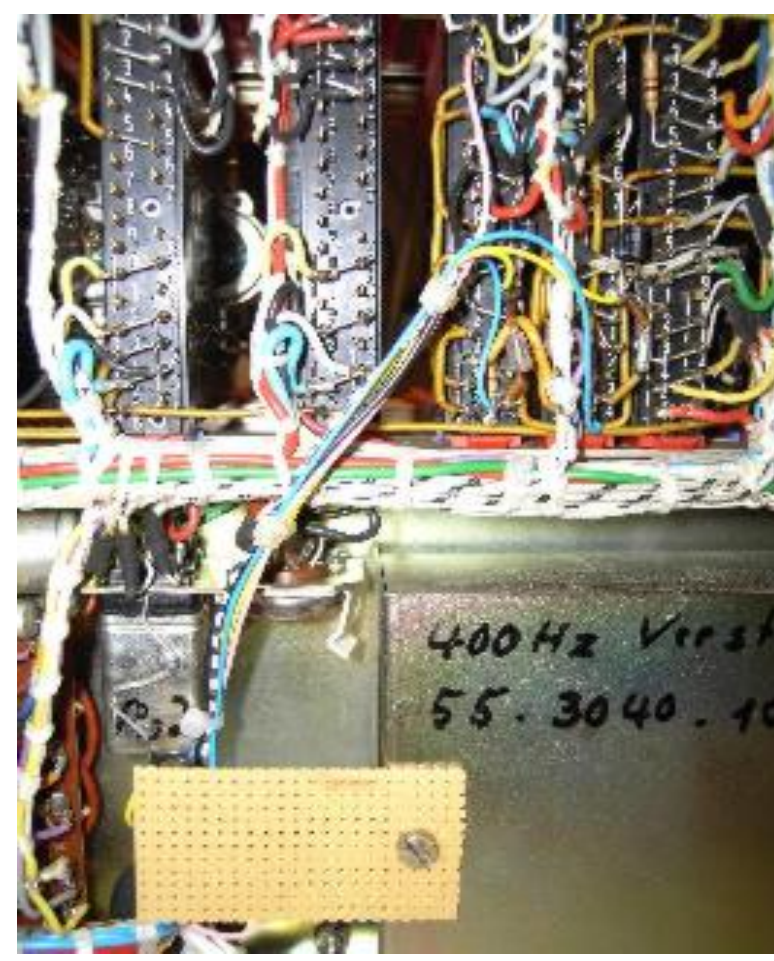
The picture on the right shows the final solution - the two OPA27 have been mounted on the frame of the 400 Hz amplifier (the writing on the case is not from me). Please note the empty tube-like relays socket on top of this contraption. This is where the now useless chopper relays was mounted which supported both of the regulator amplifiers.

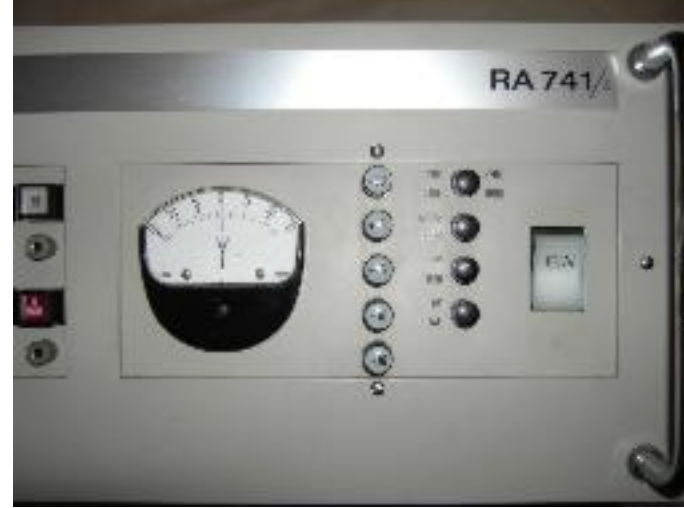
The picture on the right shows the front plate of the power supply part of the upper drawer. When powering it on all voltages are present after a couple of seconds (when you do this and hear a relays clicking for some seconds, this is perfectly normal - TELEFUNKEN used a relays to artificially unbalance the +/- 10 V regulators to force the circuit into regulation - so these two voltages will come last and only after the clicking stops).

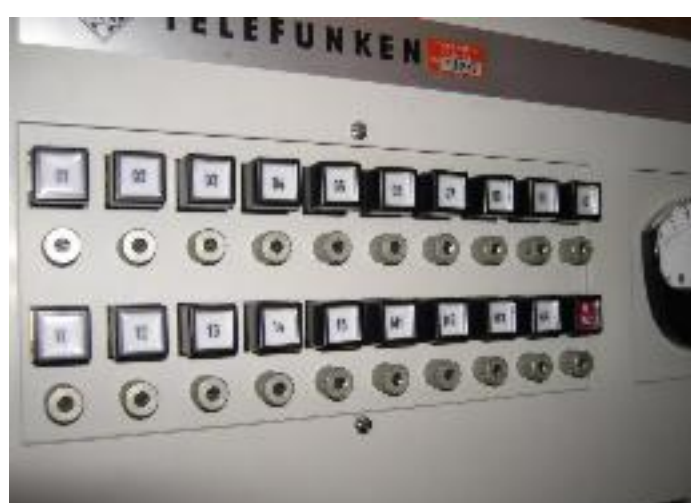
After fixing the power supply I inserted the 30 cards of the 15 operational amplifiers. The picture on the left shows the front panel of the amplifier half of the upper drawer. Each amplifier has one overload indicator (a push button which will cause the output of the amplifier to be connected to the readout bus when depressed) and one balance potentiometer (below the push buttons). When switching this drawer on, all overload indicators should light for a moment and then extinguish. Some of mine did not but fortunately I had three spare amplifiers which I used as replacement parts. After swapping these boards in, the upper drawer was operational again which I checked by testing each amplifier with a 1 kHz sinusoidal input signal of 100 mV amplitude as input. Each amplifier got its own feedback network to ensure an amplification of ten as a test bed.
