**ELECTRONIC CALCULATOR 130**

**SERVICE LETTER**

SUBJECT: Plug-in Circuit Card Jacks

SUBJECT: Plug-in Circuit Card Jacks (Friden No. 803206)

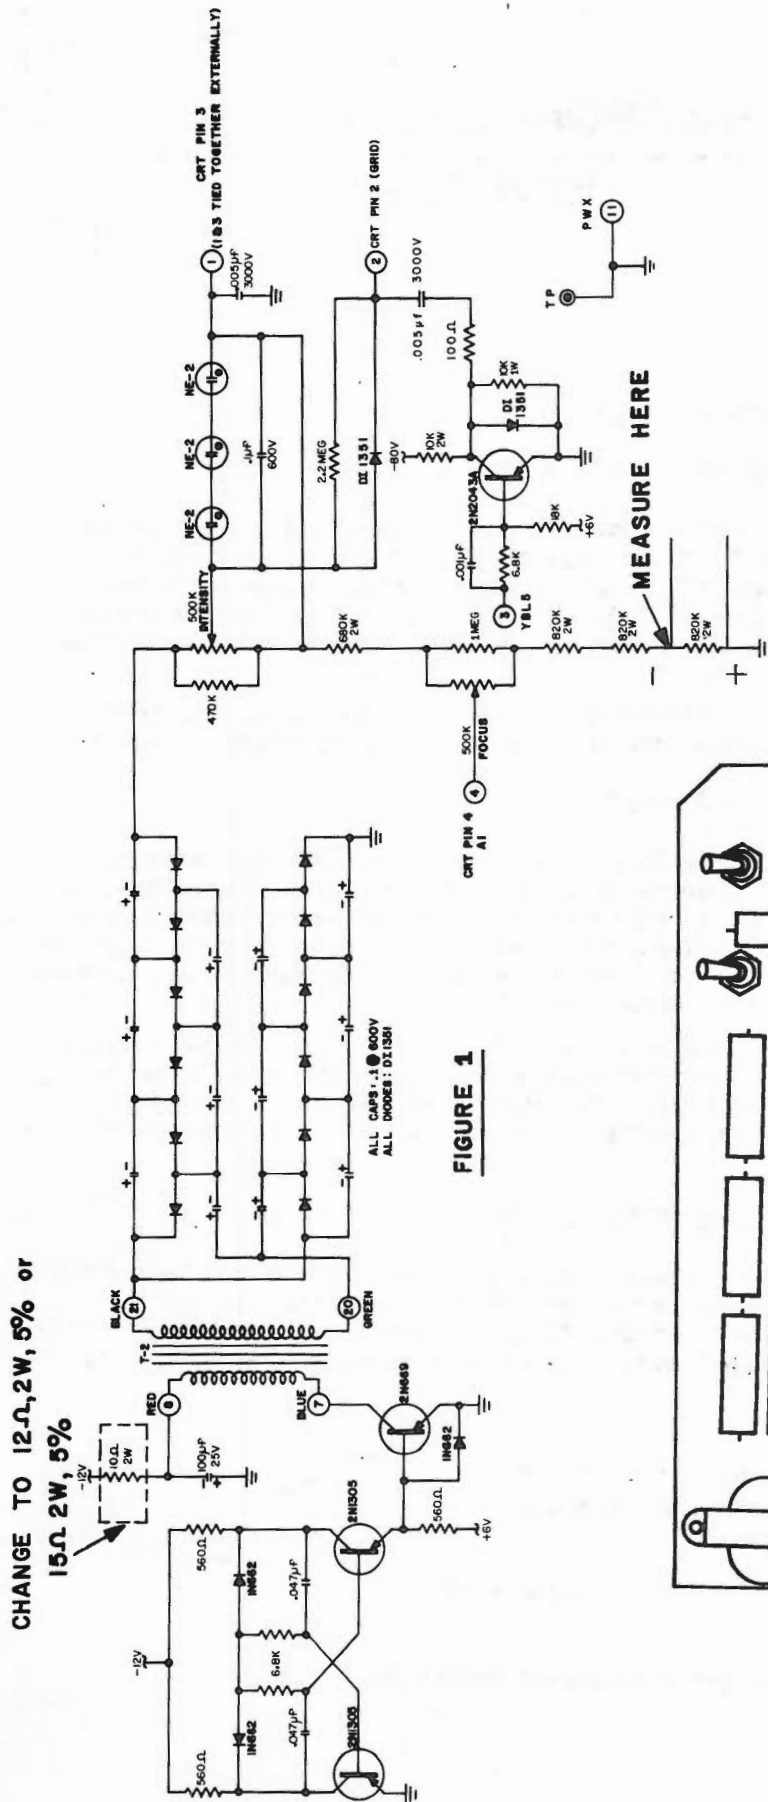
Remove the diode indicated in Figure 1. This is referenced in the EC-130 construction file under 1580.020.0 and in the EC-132 construction file under 1600.021.0. Removal of this diode will eliminate one writing pass of R1 so that R1 will be of the same intensity as R2, R3, and R4. Readjustment of the intensity control may be required. If "wavering" still persists, replace old style power transformer with new style transformer. The old style transformer has the part number (804002) stamped into the side, while the new transformer has the number on the top. The new transformer must be installed in the same position as the present one with the laminations approximately parallel to the side frame, or additional "waving" may be created.

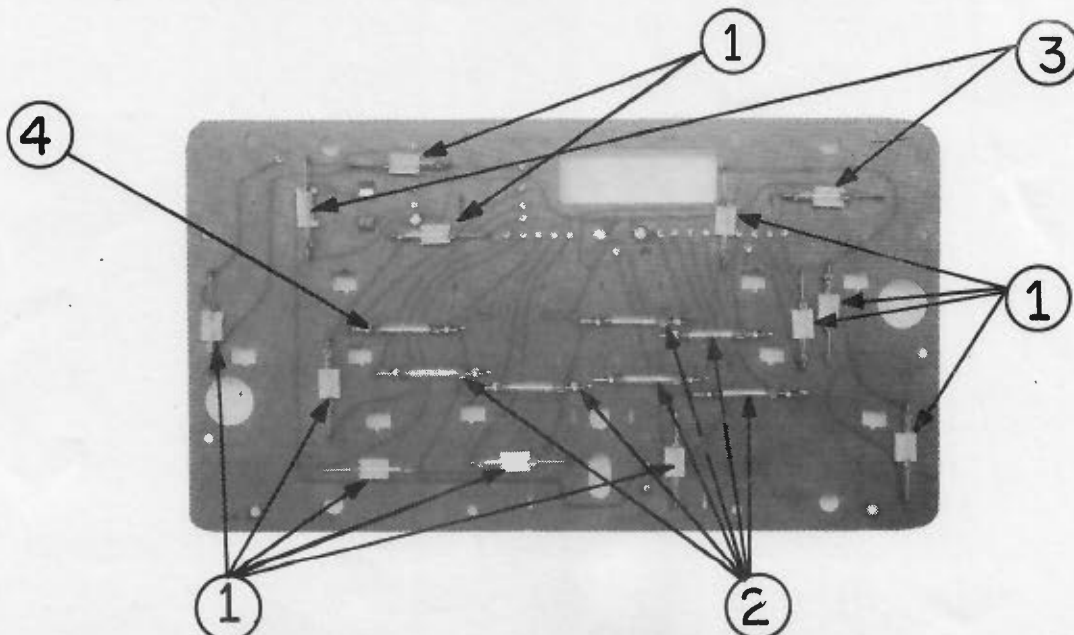
Red dot part #804132 used in positions 7 and 16. Shown as #3 in photo.

Yellow dot part #804134 used in position 4. Shown as #4 in photo.

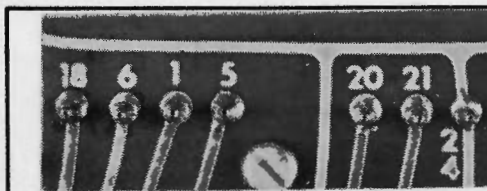
**FIGURE 1**  
PIN CONNECTIONS  
EARLY KBD  
1016 thru 4903

1. Keyboard 1016 - 4904, basic keyboard, see Figure 1.
2. Keyboard printed circuit board was changed at serial #4905 see Figure 2.
3. Decimal point switch was changed at serial #8500, and still used printed circuit board as shown in Figure 2.
